NASA TM -86560

## 5000 GPM FIREFIGHTING MODULE EVALUATION TEST

By Ralph A. Burns

November 1986

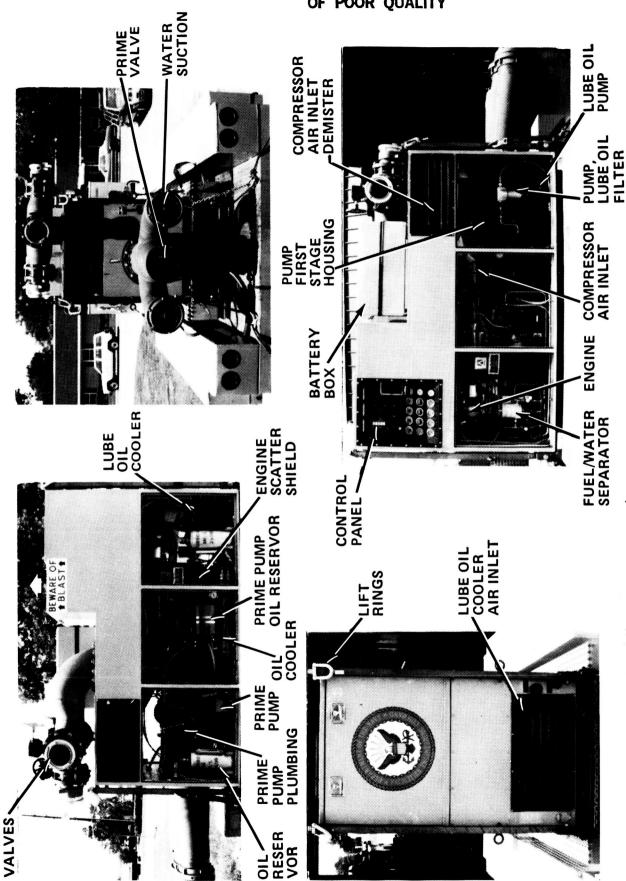
Figure 3. Module final configuration (panels removed).

final module configuration with the side door panels removed, and the more significant components identified. It should be noted that the prime pump plumbing configuration reflects changes which were made since this evaluation test was completed. The control panel is illustrated in Figure 4 with the more significant controls identified. Figure 5 illustrates the primary electronic components; one view is looking into the end compartment behind the instrument panel and the other view shows the removable printed circuit cards inside the electronic control box. Figure 6 illustrates the internal fuel tank baffles.

The prime time for a 12-ft lift was approximately 295 sec, which exceeds by a wide margin the specification requirement of 120 sec for a 20-ft lift. This prime time is excessive and could be reduced by the addition of a dual prime pump (which would also provide redundancy). Another consideration is to open up the flow passages in the plumbing lines. The current drain from a single prime pump is high — approaching 55 A at 24 V. A dual pump would require a different prime sequence than that now being used in order to conserve battery power. Instead of running the prime pump and then starting the engine after prime is completed, the engine could be started first, allowing the batteries to be charged during prime. There are two problems with this, one, the main pump is turning while the engine is running, meaning the rotating seals could be running dry, and two, during the final stages of prime, water is drawn into a rotating impeller causing surging. The first condition is probably not a real life limiting problem, however, testing could be performed to verify it. The second condition could be worked around by shutting down the engine during the final stages of prime and then restarting it after prime is completed. Since this evaluation test was completed, the Navy reported that the effective flow passage area in the prime pump suction line has been increased with a resulting improvement in prime time such that the two minute prime time can now be achieved. This change is reflected in one of the photographs in Figure 3.

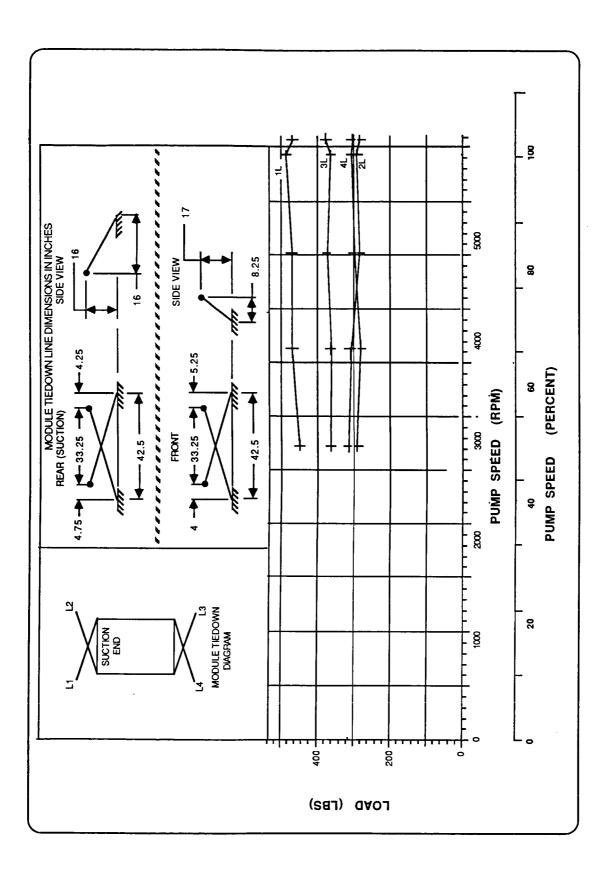
Figure 14. Tiedown loads — one side discharge open.

- 2) Tiedown load evaluation with only one of the three discharge valves open Two sets of runs were made, one with discharge flow from the side opposite the control panel; the other with flow from the rear. No significant load changes were noted. Figure 14 is a plot of the data taken with water flowing from the discharge opposite the control panel side of the module. These data are also typical of that for item 1 above.

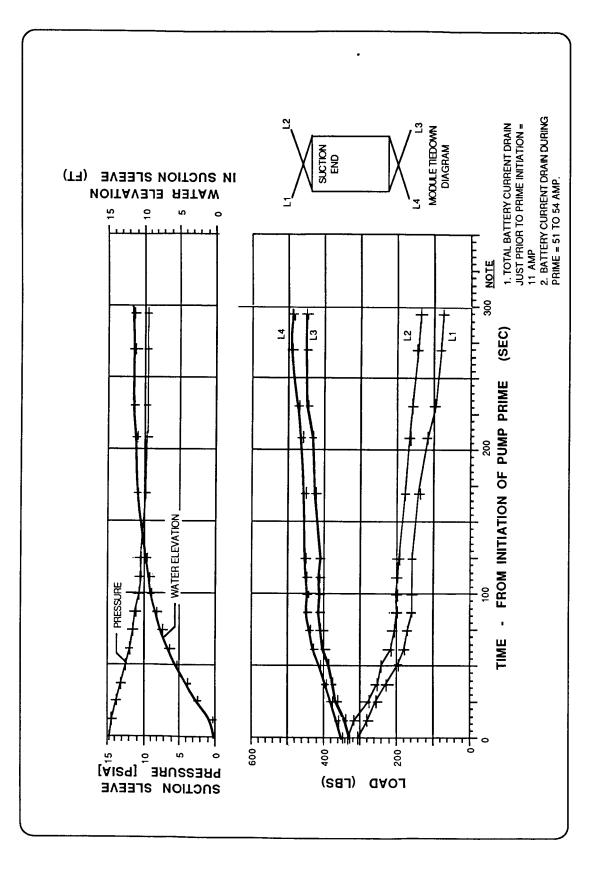
Figure 15. Prime/load test.

As can be seen in Figure 15, priming the module produces a variation in tiedown loads; as the suction sleeve fills with water, the tiedown loads on the section end of module decrease by approximately 120 lb each and the loads on the other end increase by approximately 210 lb each. By readjusting load binders after prime, a more consistent preload can be maintained during operation. These loads are the inline chain loads not the actual vertical loads. Load binder preloads of more than 400 lb should be avoided. It should be noted that during 1984 testing with the original pump impeller, severe vibration and recirculating flow conditions occurred in the pump suction at high back pressure conditions. During the September 1985 test, being reported here, significantly smoother module operation occurred under these conditions.

- 6) Prime Test Figure 15 is a typical prime cycle. The time to prime for a 12-ft lift was approximately 295 sec with a battery drain averaging 51 to 54 A with both batteries providing power. The plots illustrate the rate at which water is drawn up the suction sleeves as well as the change in tiedown load as the suction sleeve fills with water.

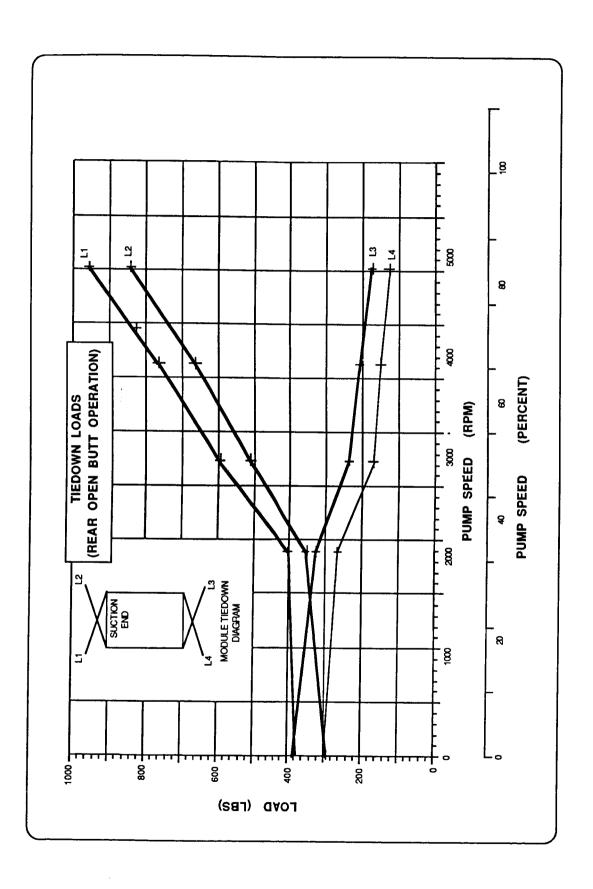
Figure 16. Tiedown loads — open butt.

- 3) Tiedown load evaluation with one discharge hose removed and water flowing open butt This test simulates the effect of a hose/coupling failure. Figure 16 data were taken with the discharge hose removed from the rear discharge elbow and water flowing only through this elbow. It illustrates an approximate 520 lb inline chain load increase on each chain on the suction end of the module as the pump speed is increased from 1800 to 4500 rpm. At the same time, the inline chain load on the end of the module opposite the suction is decreased by approximately 150 lb.

The module was operated with one of the discharge hoses removed to simulate the effects of a failed discharge hose coupling. Immediate and significant load increases occurred as the speed and power level were increased. Due to the indicated real time increase in loads and vibration, these tests were stopped short of achieving full speed and power levels. It is recommended that frequent pressure tests of the discharge hose near the module be made at regular intervals. A heavier duty hose/coupling at this point is also recommended. Water hammer effects as a result of sudden or intermittent flow interruption could also be a significant hazard. (No attempt was made during test, however, to simulate this condition.) The fix for this condition is to set the module up such as to eliminate the possibility of a sudden flow interruption.

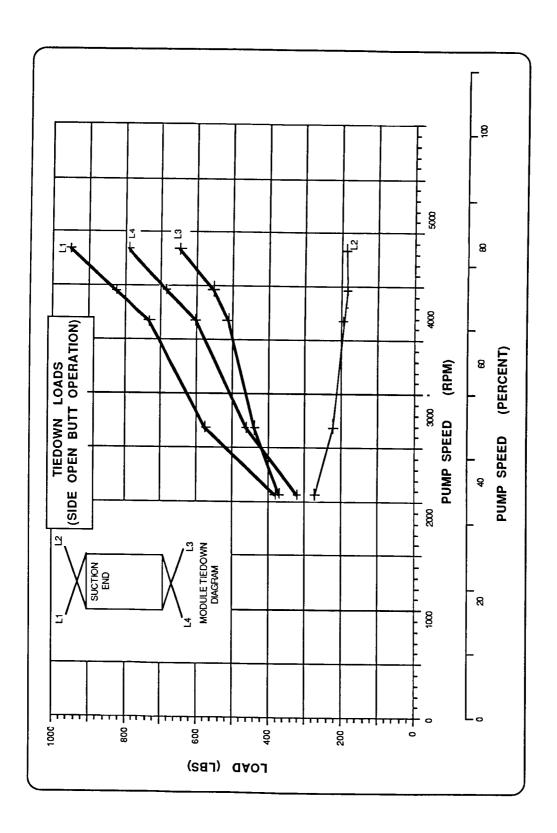
Figure 17. Tiedown loads — side open butt.

Figure 17 data were taken with the discharge hose removed from the side discharge elbow opposite the control panel and water flowing through that elbow. The L1 chain inline load increases by approximately 570 lb while the other side, L2, decreases by 80 lb as the speed is increased from approximately 2100 rpm to 4350 rpm. On the other end of the module, L4 is increasing by approximately 465 lb, while L3 is increasing by 275 lb. The suction end of the module appears to be trying to rotate. The weight of water in the suction hose appears to transfer the water thrust from the elbow into a rotating and lifting motion on the other end of the module. The maximum speed was limited by the module operator due to the dramatic increase in tiedown loads and a noticeable change in vibration and noise. Figure 18 combines the plots from Figures 16 and 17 for comparative purposes. These data indicate that large module lifting/rotating loads can be developed as a result of a failed hose connection at the module hose interface. It has been previously demonstrated that these type loads are sufficiently high to rotate and turn the module over (in the event of a tiedown failure). The module tiedown connect points were redesigned prior to this test and are considered adequate. From an operational safety standpoint, a primary concern is the reliability of the discharge hose and fitting — a heavier duty hose/ connection would be an improvement along with a hose pressure test at regular intervals. The chains and tiedowns to the trailer, of course, must be adequate. The previous problems of reverse flow in the suction hose and heavy vibration at high back pressures were not encountered during any of these tests.

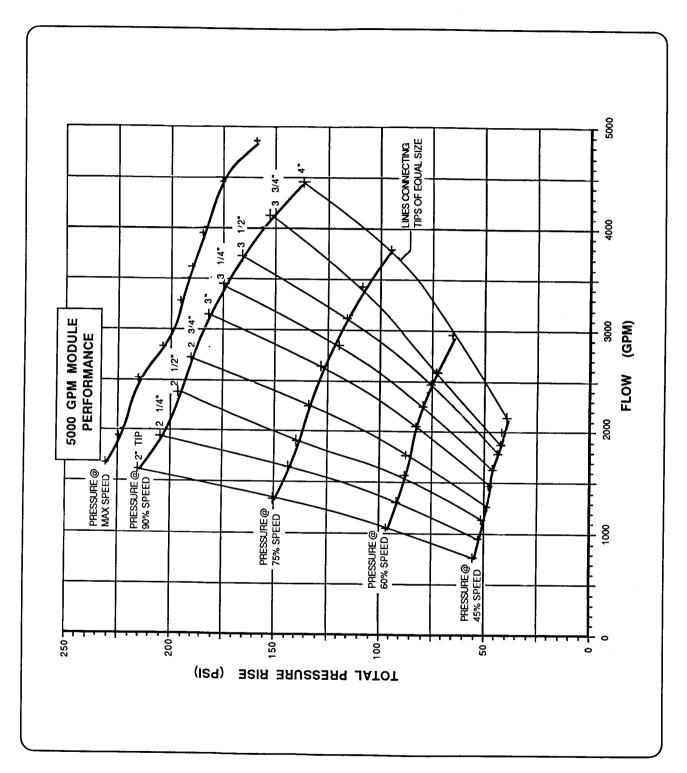
Figure 19. Performance.

4) Performance evaluation with the Stang 8-in. water cannon — Figure 19 is a plot showing module performance at 45, 60, 75, and 90 percent speed and maximum speed. (Maximum speed was that speed judged to be the maximum attainable without exceeding the automatic over temperature shutdown limits — a digital total outlet temperature, TOT, reading of 713°C and a panel gauge reading of 730°C.) Additional investigation should be performed to determine which of these TOT values represent the true temperature. The inlet air temperature for these tests ranged from 72 to 76°F.

Lines are drawn on the plot which connect test points representing the different tip sizes tested. Figure 20 is a comparison of performance and horsepower at 90 percent and maximum flow conditions. In running the maximum flow condition test, an attempt was made to keep the speed as high as possible without getting an automatic TOT shutdown, hence, the speed varied somewhat resulting in an uneven flow and horsepower curve. The variation in speed can be seen in Figure 21.

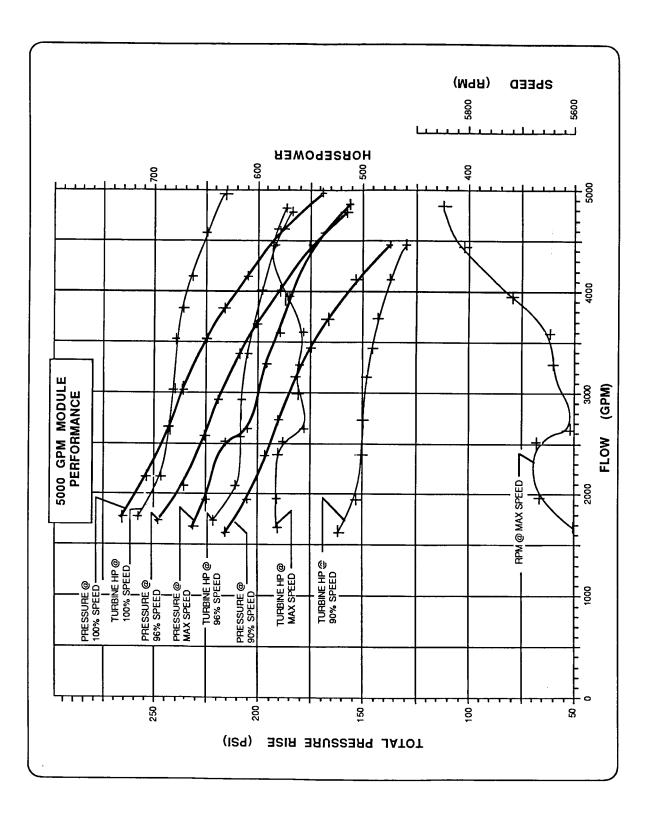
Figure 21. Performance.

As can be seen from Figure 21, extending the maximum pressure curve indicates that the 5000 gpm flow was probably achievable, however, it would have required a nozzle larger than the 4 in. available, in order to reduce the tip pressure drop. The 3000 gpm performance was achieved. The 2500 gpm performance could not be achieved, due primarily to a lack of engine horsepower. The engine horsepower criteria was specified at conditions of standard day temperature and sea level conditions, the test was actually run at average temperature conditions of approximately 73°F. The actual test conditions subtract approximately 50 horsepower from that normally available at specification conditions, however, the engine capability is still short of what is required to achieve the 2500 gpm requirement. The 100 percent speed curve indicates that the module could have achieved 2500 gpm at aproximately 245 psi if approximately 685 engine horsepower were available. For the inlet temperature condition of approximately 73°F and a TOT of 713°C, only 570 to 585 horsepower was indicated as being available. The inability of the engine to develop sufficient horsepower was recognized by the Government prior to awarding the module contract. The Allison engine was an uprated version of the previously used module engine and was the only one known with an output drive pad location near the center of the engine which was compatible with the original module pump configuration and would result in a minimum overall module length.

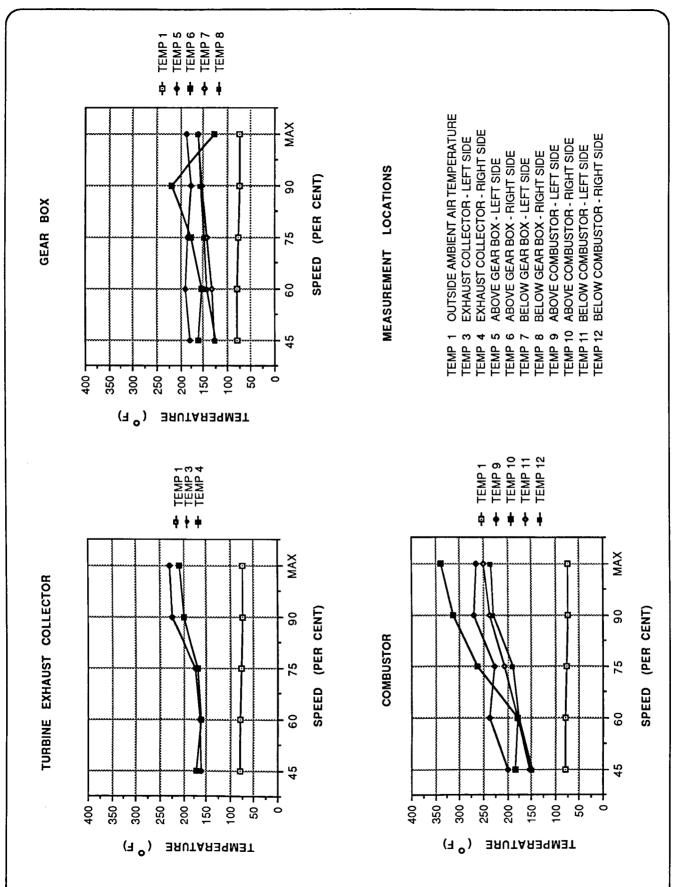
Figure 23. Engine compartment air temperatures.

Figure 22, Table 3, illustrates the changes in some selected parameters as the tip sizes are changed while attempting to maintain maximum speed. The test setup is with the Stang water cannon set up as per basic module setup number 1. Compartment temperatures were relatively low. Figure 23 illustrates typical temperatures. The data shown was taken from the performance testing with the Stang water cannon and a 2-in. tip.

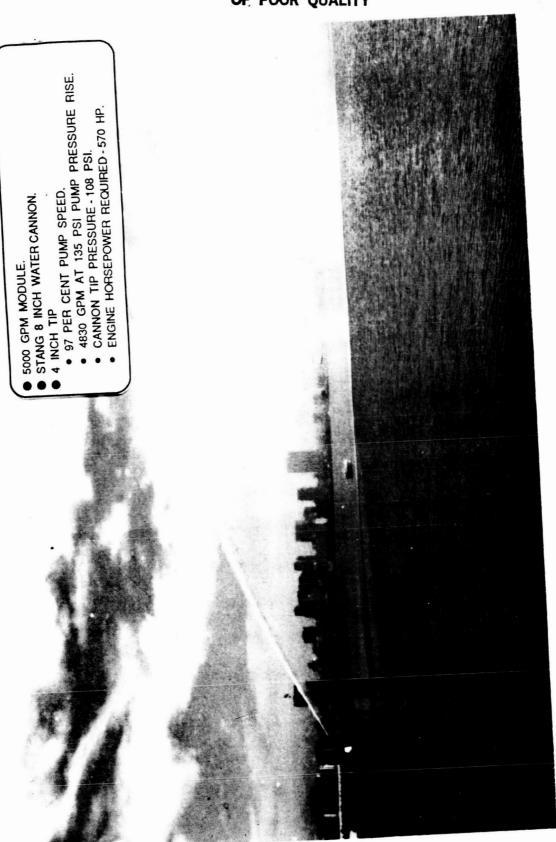
Figure 24. Water stream reach, 4-in. tip.

During flow performance testing, photographs were made of the water stream at each test speed, 45, 60, 75, 90 percent and maximum, and with tip sizes from 2 in. to 4 in., in 1/4-in. increments to illustrate the reach and general condition of the stream for each case. Figures 24, 25, and 26 are photographs taken of the water stream with tip sizes of 4.00, 3.75, and 3.50 in., respectively, with the module operating at what was considered to be the maximum engine power level for the prevailing ambient temperature conditions. Of the nine tips tested, the maximum stream reach appeared to be with the 3.50 in. tip, while operating at maximum speed.

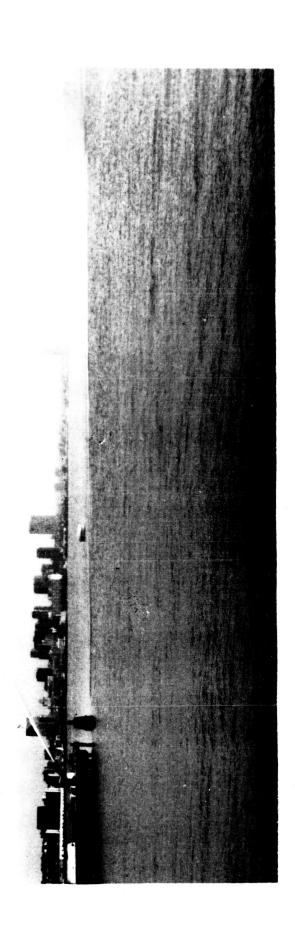
Figure 25. Water stream reach, 3.75-in. tip.

97 PER CENT PUMP SPEED.
4440 GPM AT 175 PSI PUMP PRESSURE RISE.
CANNON TIP PRESSURE - 132 PSI.
ENGINE HORSEPOWER REQUIRED - 585 HP.

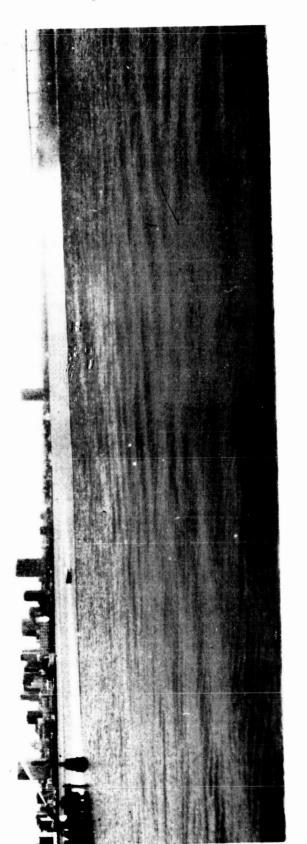
Figure 26. Water stream reach, 3.50-in. tip.

- 5000 GPM MODULE.
  STANG 8 INCH WATER CANNON.
  3.50 INCH TIP
- 95 PER CENT PUMP SPEED.
  3950 GPM AT 185 PSI PUMP PRESSURE RISE.
  CANNON TIP PRESSURE 149 PSI.
  ENGINE HORSEPOWER REQUIRED 570 HP.

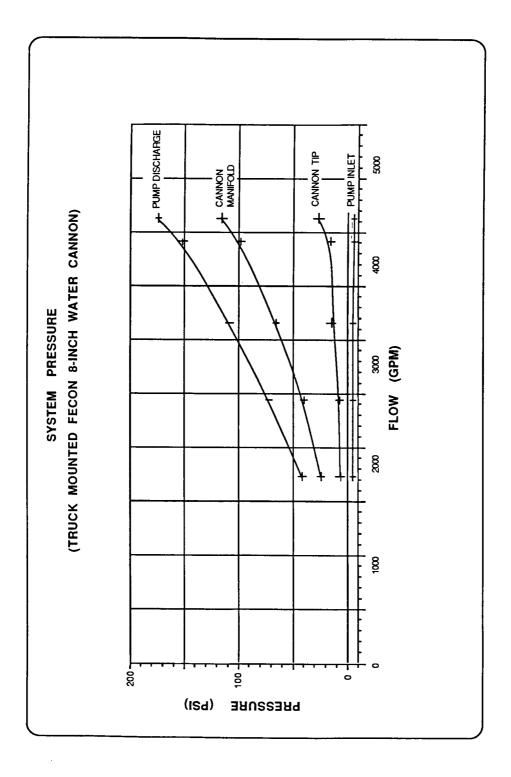
Figure 27. System pressure, Fecon.

- 5) Performance evaluation with the truck mounted Fecon water cannon Figure 27 is a plot illustrating how pressure increases at various points in the system as the water flow rate increases. Figure 28 is a similar plot but with module set per basic module setup number 1 with the Stang water cannon. Figure 29 compares the pressure drop of the Fecon 8-in. cannon and Stang 8-in. cannon. As can be seen, there is a very large pressure drop difference between them at high flow rates. It appears that a redesign of the Fecon cannon is in order to reduce this difference.
